Naval Research Laboratory

NRL/MR/8150--97-7922

Truetime Model GPS-DC-552 MK III GPS Receiver Live Static Test

April 14, 1997

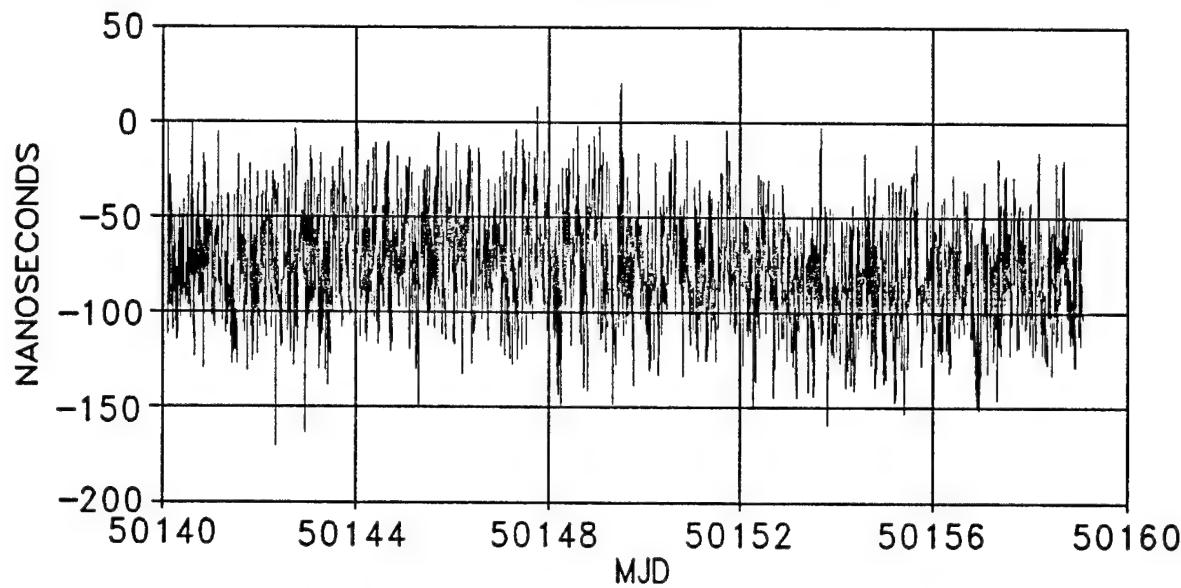
Figure D.1. True Time MKIII receiver time error VS USNO(MC2).

A detailed calibration of all MK III timing system errors were completed. The MK III 1PPS time signal, when averaged over time intervals of 24 hours, and covering a period of three months was found to be lagging GPS time by 76.1 ± 4.5 nanoseconds. A segment of this data is shown in figure D.1. The GPS scale is steered⁶, as needed, on a daily basis to be within one microsecond of UTC(modulo one second). During long term testing it was found that the MK

During long term testing it was found that the MK III does makes the integer leap second correction to UTC but not the required fractional second of GPS to UTC(USNO) time corrections as specified in GPS ICD-200. GPS time is typically maintained to within ± 30 nanoseconds of UTC(USNO) time, and GPS time is only required to be within ± 1 microsecond at present. The problem was verified by Truetime and will be fixed for future units. Thus the measured bias is composed of receiver system bias and the uncorrected UTC(USNO) offset to GPS time. The average UTC(USNO) GPS bias for the test period was 0 nanoseconds leaving a net bias of 76.1 ± 4.5 nanoseconds due to the receiver.

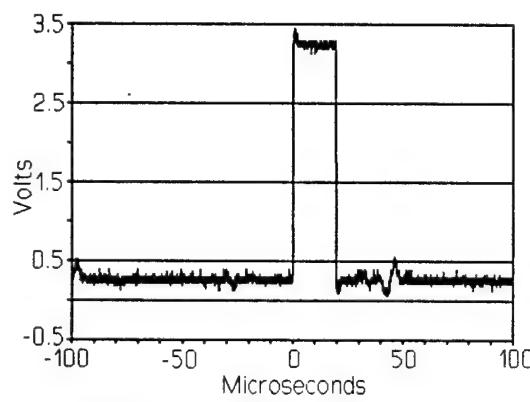
Figure D.2. 1PPS output.

The output 1PPS is a TTL-type logic level compatible, positive-going, 20 microsecond wide pulse when driving a 50 ohm load impedance. Table 4 contains a summary of these measurements. The full pulse is shown in figure D.2 with an amplitude of 3.4 volts with a slight overshoot. Figure D.3 shows that the MK III 1PPS timing signal has a very fast rise time of 1 nanosecond. The fall time is shown in figure D.4, also 1 nanosecond. Figure D.5 shows unwanted EMI leakage from the IRIG circuitry that bleeds into the 1PPS output.

The output 1PPS is a TTL-type logic level compatible, positive-going, 20 microsecond wide pulse when driving a 50 ohm load impedance. The full pulse is shown in figure D.2 with an amplitude of 3.4 volts with a slight overshoot. Note the output level is not 10 volts peak pulse as requested in the TGR specifications. Figure D.3 shows that the MK III 1PPS timing signal has a very fast rise time of 1 nanosecond. The fall time is shown in figure D.4, also 1 nanosecond. Figure D.5 shows unwanted EMI leakage from the IRIG circuitry that bleeds into the 1PPS output.

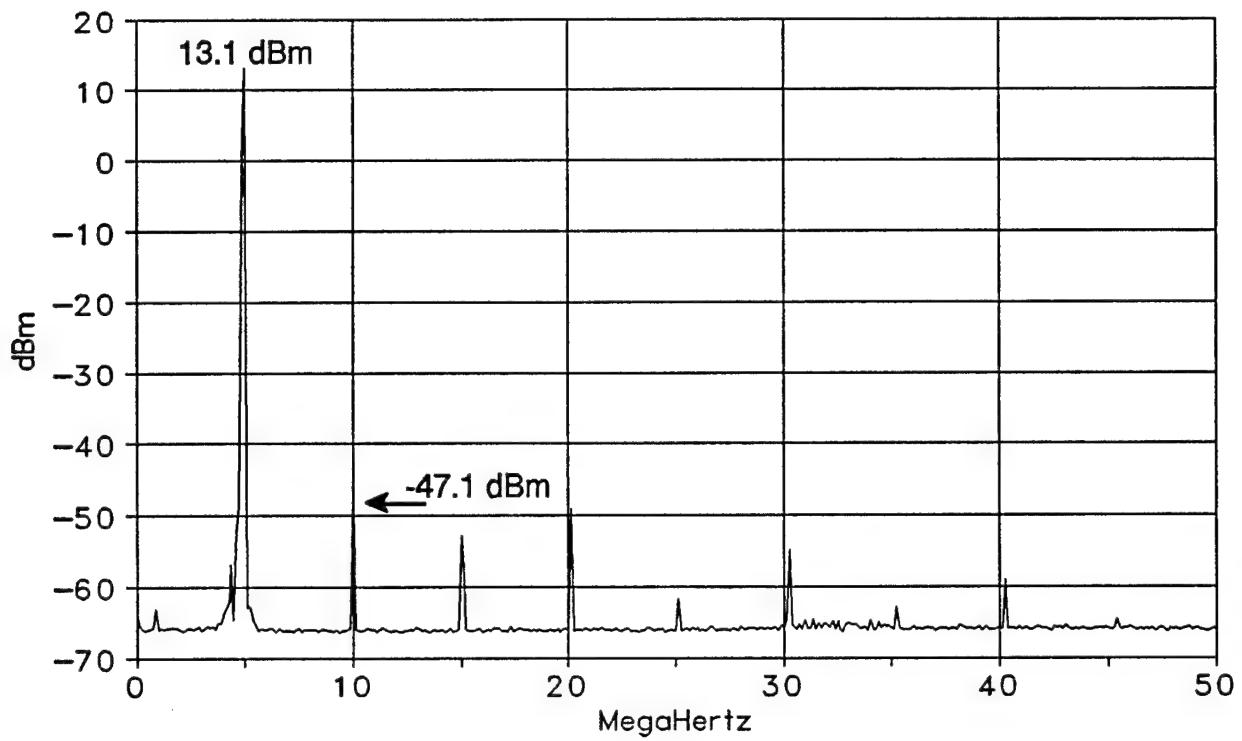
Figure D.6. 5MHz output with harmonics out to 50 MHz.

The Truetime MK III primary frequency outputs have a signal level of + 13 dBm, figure D.6 shows the 5 MHz output and its harmonic content out to 50 MHz. Numerous unwanted frequency spurs can be seen in figures D.7 and D.8 but all are within specification. The summary of the test results are shown in table 5.

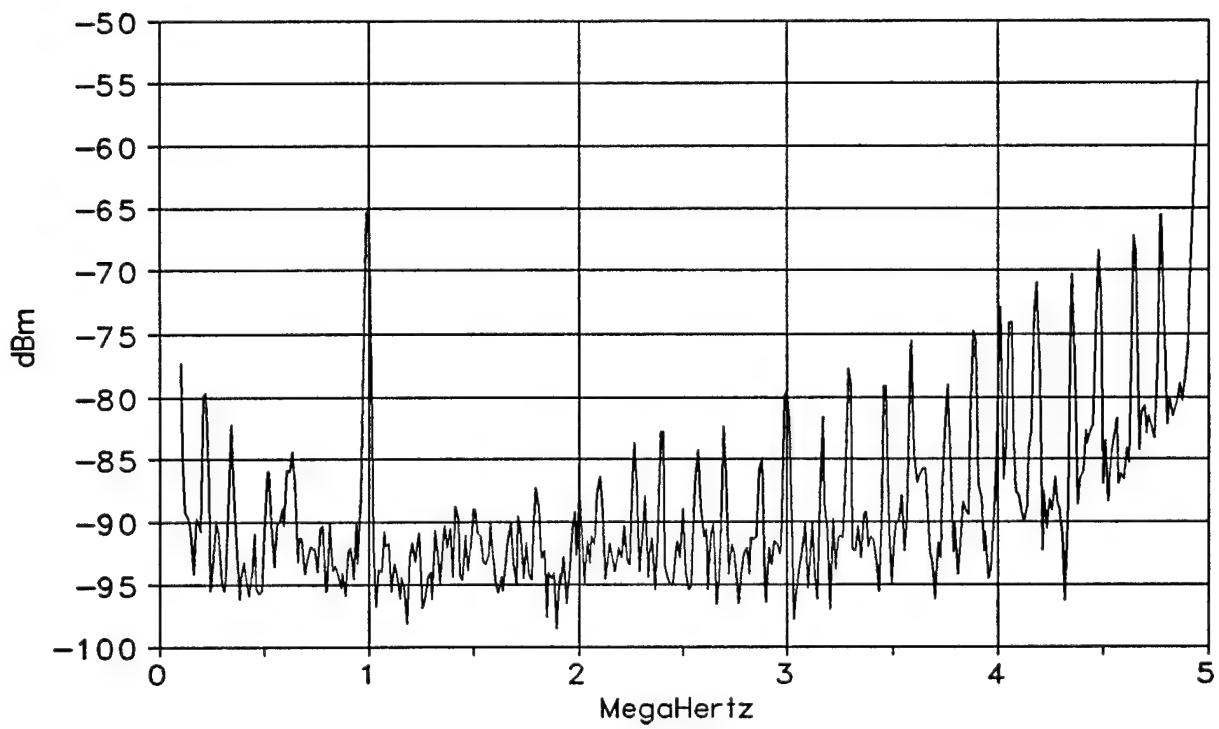
Figure D.7. 5 MHz output from 100 kHz to 4.95 MHz. 1/4 wave trap at 5 MHz.

Figure D.7 is a plot of the frequency spectrum from 100 kHz to 4.95 MHz using a quarter-wave trapping stub to attenuate the main 5 MHz signal. This method increases the dynamic range of the analyzer and pulls small signals out of the analyzer system noise. Note the crosstalk into the 5 MHz output coming from the 1 MHz frequency output displayed in this plot. Also note the numerous frequency components approaching the fundamental. These are believed to be Amplitude Modulation artifacts from a 78 kHz signal detected in the single sideband phase noise plots shown later in this paper. All observed discrete frequency components were well below the manufacturer's and TGR specifications.

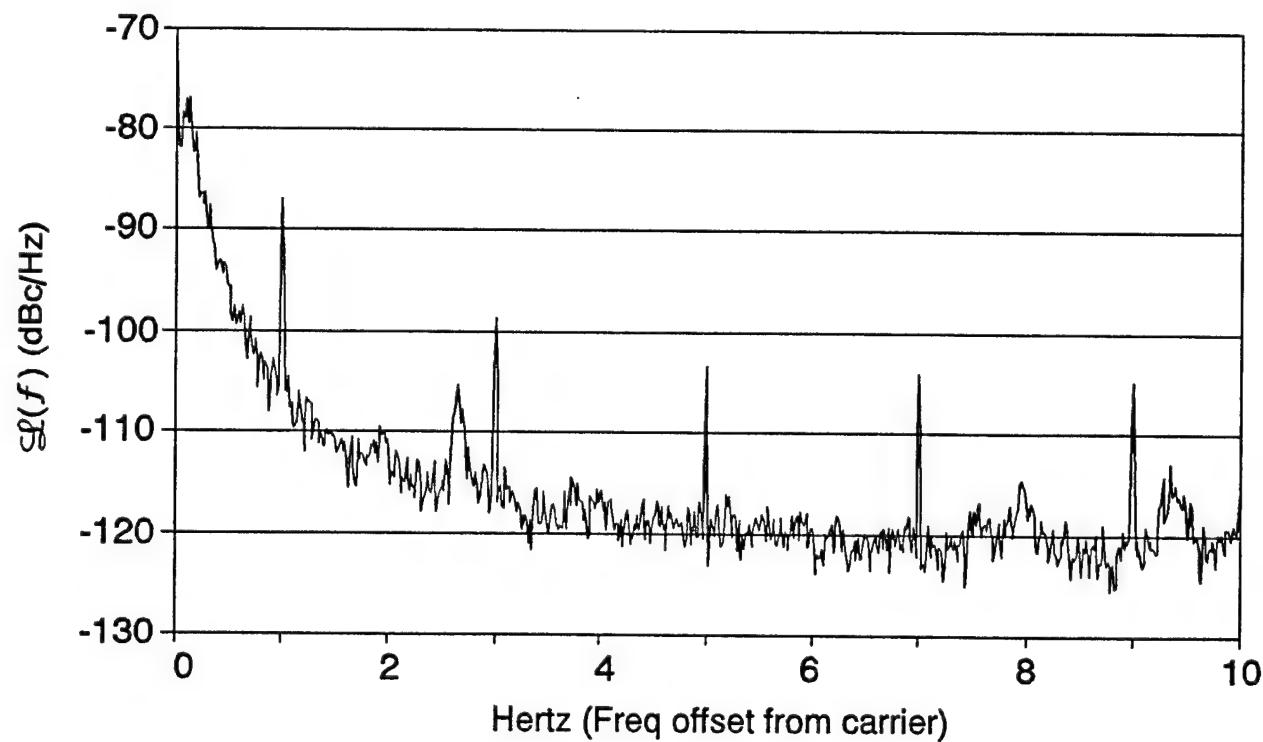
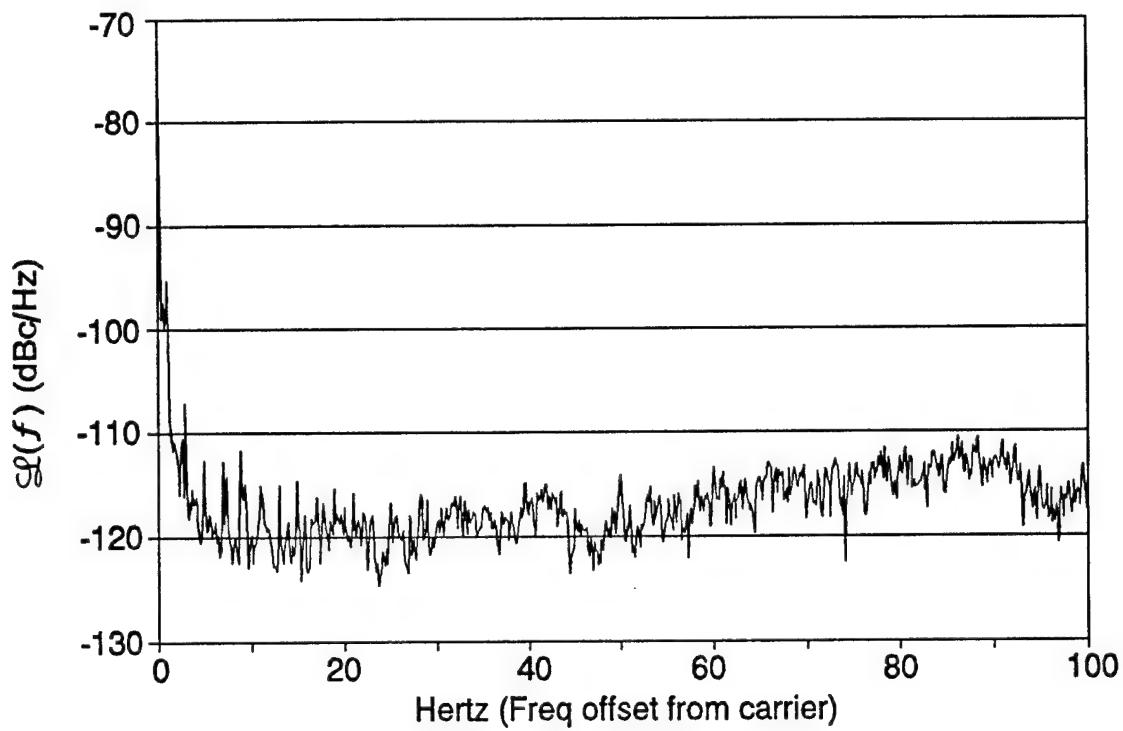
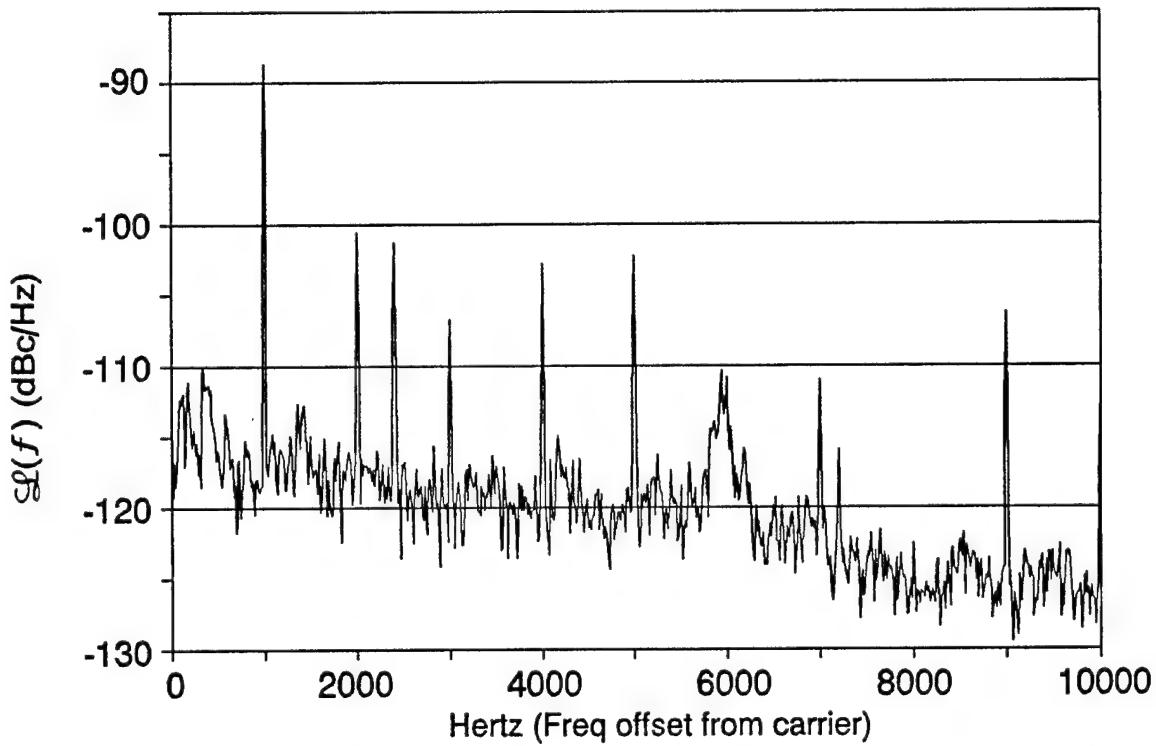
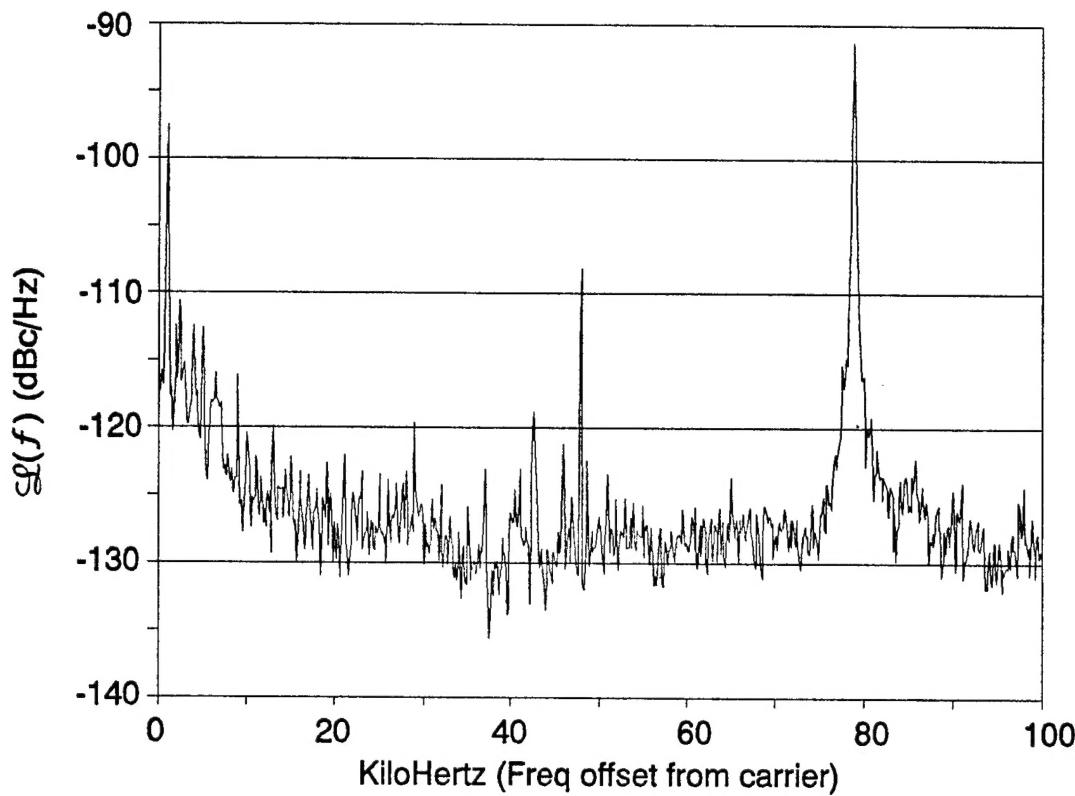
The 5 MHz sine wave output on the rear panel was examined for phase noise and spurious content. The MK III receiver has a phase noise floor at -127 dBm with a number of spurs that can be seen in figures D.9 through D.12. The 1PPS timing signal is clearly shown bleeding over into the frequency outputs in figure D.9. A particularly large peak can be seen in figure D.12 at about 78 kHz, this may be due to the receiver's switching power supply. General results are shown in table 6.

Figures D.9 through D.12 are made from the NRL single sideband phase noise measurement system. They cover a span from 10 Hz to 100 kHz. All figures are in units of dB below carrier, dBc or $L(f)$. Figure D.9 is a very narrow band look at the carrier. It shows some leakage of the 1PPS signal into the frequency outputs. Figure D.10 is free of any unusual signals, even around the 60 Hz area where power line interference usually occurs. Figure D.11 shows the signal out to 10 kHz. The 1 kHz signal seen in figure D.11 is believed to be crosstalk from the IRIG circuitry. Figure D.12 shows a strong 78 kHz frequency component. All observed signals are well below the TGR and Truetime specification. The overall phase noise floor of the Truetime MK III was 6 dB above the TGR specification of -135 dBc.

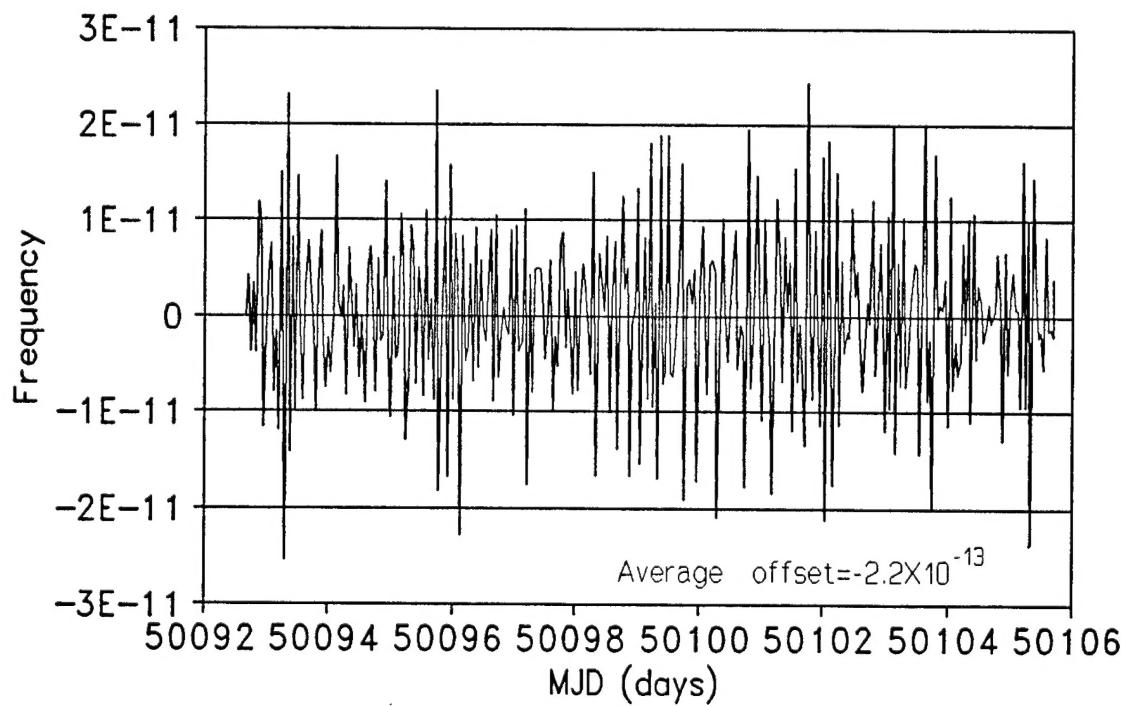
Figure D.13. Frequency data of the receiver's 5 MHz output.

The absolute frequency offset of the 5 MHz sine wave output with respect to USNO was measured. The data is shown in figure D.13 with the results shown in table 7. The MK III frequency measurement value is the result of data averaged from (10) 3 hour averaging periods per the TGR SCN-3 specifications.

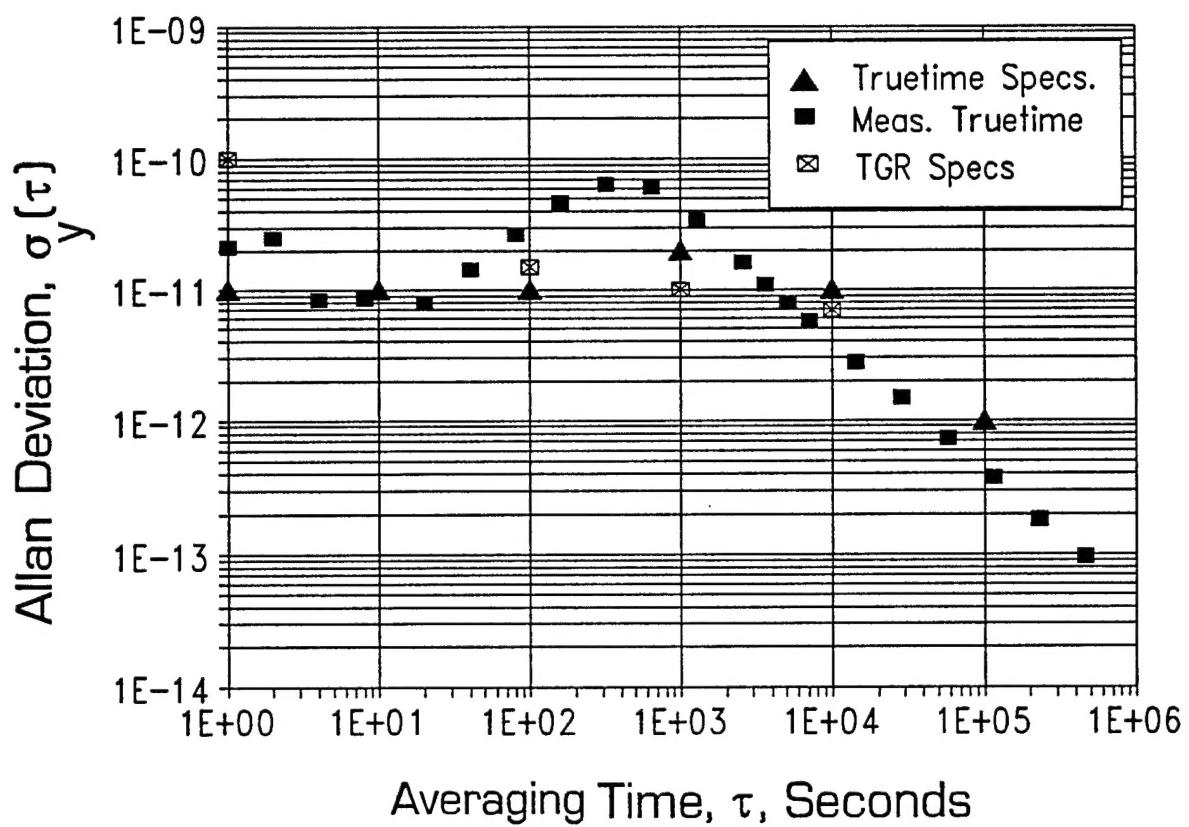
Figure D.14. Allan Deviation plot of the frequency data and specifications.

Phase data was taken from the 5 MHz sine wave output at one second intervals for one hour and at one hour intervals over 64 days. These two data sets were used to calculate the Allan Deviation for sample periods of between 1 and 500,000 seconds with the results given in table 8. The MK III did not meet the TGR SCN-3 frequency stability specification at 100 and 1000 second.

Phase data was taken from the 5 MHz sine wave output at one second intervals for one hour and at one hour intervals over 64 days. These two data sets were used to calculate the Allan Deviation for sample periods of between 1 and 500,000 seconds. Figure D.14 is an Allan Deviation, $\sigma_y(\tau)$, plot of the frequency data. The slight rise in the Allan Deviation at the one second sample intervals was a result of the 1PPS leakage referred to in section D.1.5. The peak occurring at 300 seconds is due to the SA and the servo loop steering in the MK III. The Allan Deviation of figure D.14 does not satisfy the TGR specifications at 100 and 1000 seconds.
